Copy of EWB-Tufts Internal Trip Report

ENGINEERS WITHOUT BORDERS-USA
TUFTS UNIVERSITY STUDENT CHAPTER

El Cristal, Ecuador Summer 2010 Trip Report

Travel Dates: August 17, 2010 – August 29, 2010

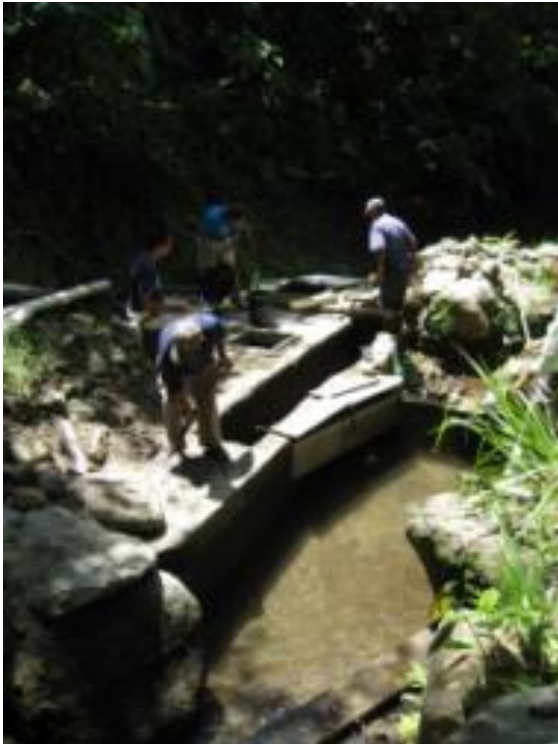
View looking downstream of converging streams at capture tank system. Large tank at bottom of picture is the first settling tank. Water moves from this tank to the long skinny tank in between the first two men, then through the screen and into the covered tank before flowing to the SSF unit.

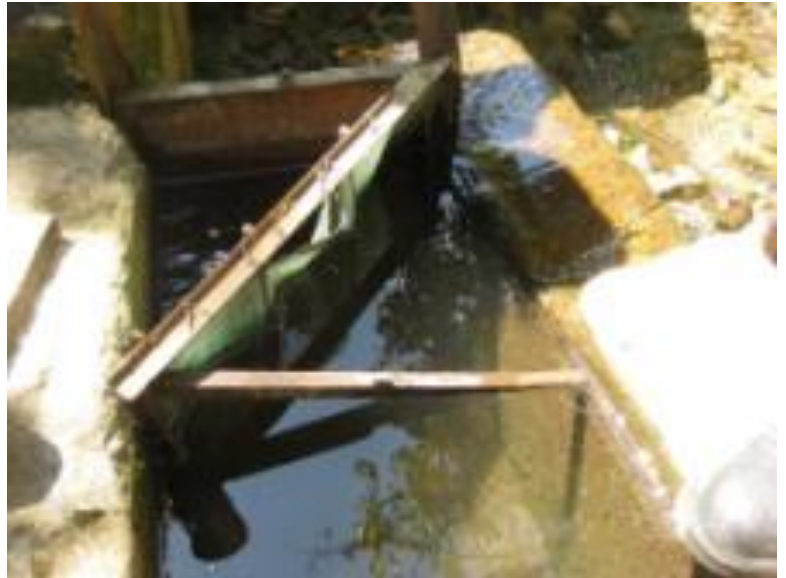
Screen used to remove large debris with space between edge of screen frame and side of enclosed tank allowing for larger particles to pass through.

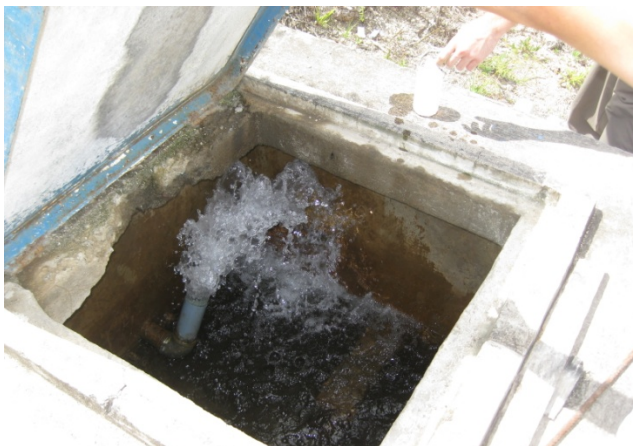
The slow sand filtration unit (near the center of El Cristal) consists of a capture box, two slow sand filter tanks so that one is operating while the other is being cleaned, a splitter box that sends about 2/3 of the filtered water to Peñaherrera and 1/3 to El Cristal, weir box, and a large surge tank. Piping from the surge tank distributes the water each receiving household. There is also

bypass piping from the first capture tank that goes directly to the splitter box. The following is a step by step description of each component of the slow sand filtration unit. Designs of the unit with dimensions can be found in Appendix D.

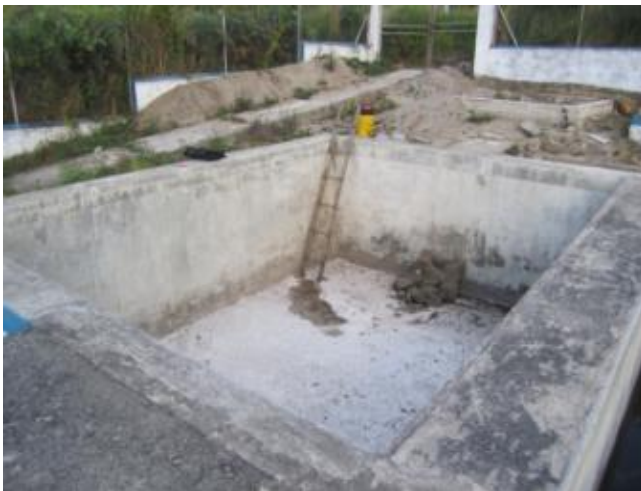
West filter when drying

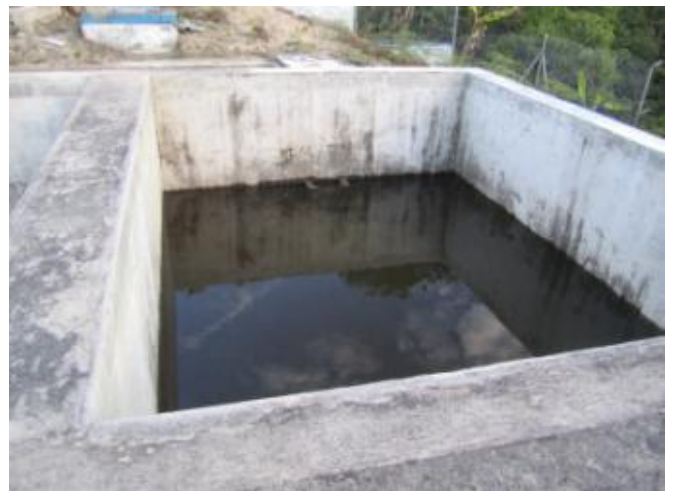
East filter in operation

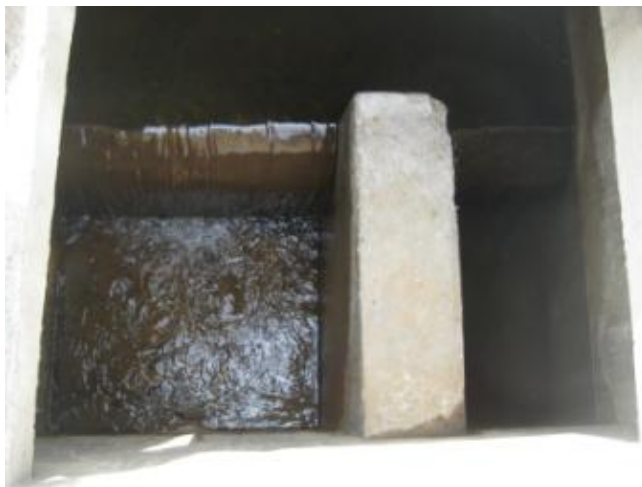
After treatment, the outflow water enters the covered split box depicted on the left. As suggested by the photograph, 2/3 of the water coming from the slow sand filter is directed to Peñaherrera while 1/3 of the filtered water is directed to Cristal's water distribution system. The level of water in the Peñaherrera side and the Cristal side are usually different. More commonly, the water on the Peñaherrera side of the split box was at a lower level than the water on the Cristal side.

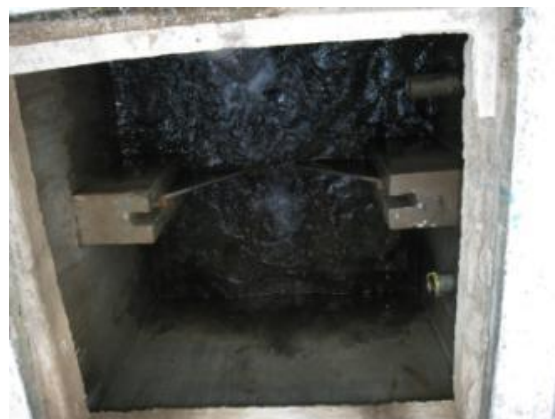
The filtered water flows through the covered weir box before entering the large surge tank for distribution. This weir box serves as a capture tank for the surge tank. Samples for water quality testing denoted as water after filter treatment were taken from this weir box. The flowrate of water used to calculate the superficial velocity of water moving through the operating filter was also measured at this weir box. An inlet pipe enters the box near the top, making it possible to measure flowrate with a bucket and stopwatch. Also, the weir appears to be at a right angle, allowing for another method of flowrate measurement. The weir box has an overflow pipe and an outflow pipe that leads to the surge tank.

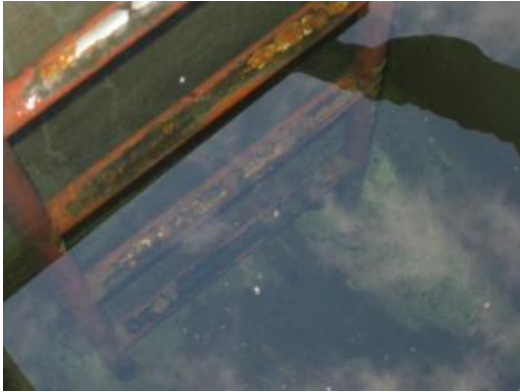
Filtered water is stored in the covered surge tank before being distributed to households connected to System 1. Residence time in this tank varies. In the morning this tank was usually observed to be full while at night it was usually observed to be near empty. Particulate matter in the tank is visible upon opening the lid. Small insects are also seen on the water surface. Also, the ladder leading to the bottom of the tank is substantially rusted. It is likely that metal is dissolving into the water.
